# GARDEN CITY SKYWAY SUBSTRUCTURE REHABILITATION

Issam ElKhatib, P.Eng., Dennis Baxter, P.Eng.  
Totten Sims Hubicki Associates, Canada

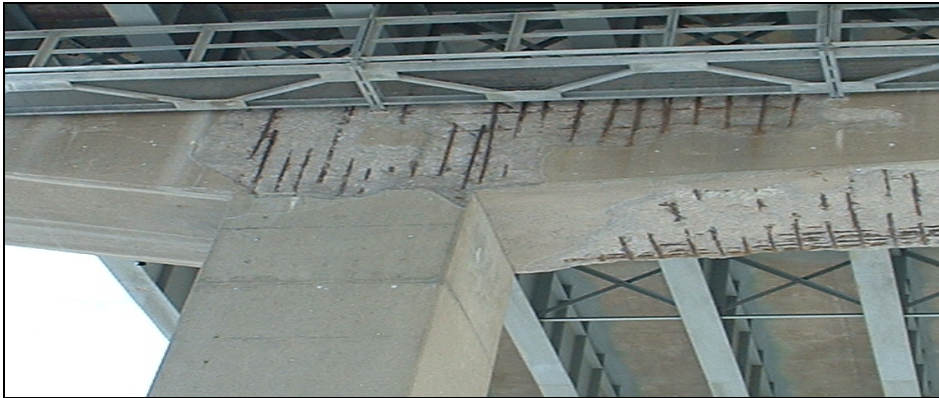
condition. Due to chloride contamination through the open deck joints and deterioration of sealed deck joints over the years, significant deterioration (scaling, delaminations, spalls and cracks) of the bearing seats, pier caps and pier columns has occurred.

**Figure 2: Typical spalls on pier cap of pier W11**

Alternative 1 consists of repair of concrete substructure components by forming and pumping of concrete patches. This alternative has an anticipated service life ranging between 10 to 20 years depending on exposure to future chlorides. The service life can be extended to minimum of 25 years by the introduction of passive cathodic protection systems (see alternative 6 for description). Patching has been considered for piers with deterioration not exceeding 30% of the surface area. The following construction staging was incorporated into the detail design of patch repairs:

- Removal beyond the mid-point of the main reinforcing steel bars (45M) in the pier cap soffit was restricted to removal of unsound concrete only. In addition, removal along the length of the cap was staged to maintain stresses in the pier cap within tolerable limits. In areas of restricted removal, steel mesh reinforcing and anchorage inserts were provided to improve patch adhesion in the absence of placing concrete around the reinforcing steel bars.

- Similarly, removals from the vertical faces of the pier cap were restricted to one face at a time to prevent loss of shear capacity.
- Removals from pier columns were also staged to maintain the structural integrity during construction.

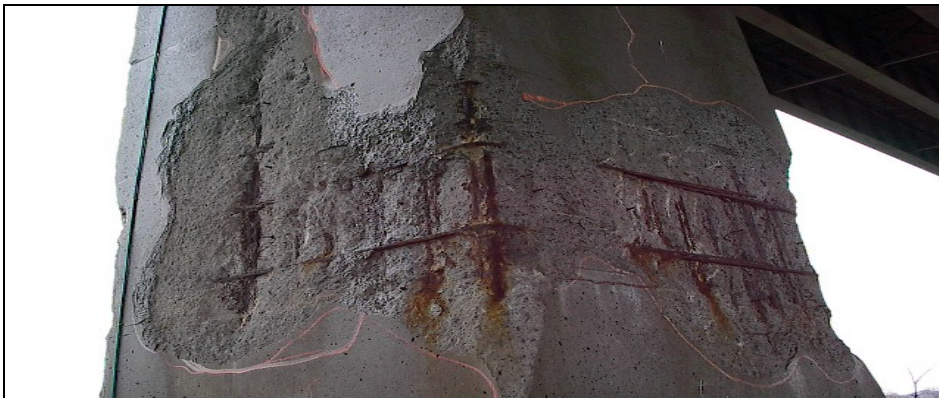
**Figure 3: Typical spalls on south column of pier W17**
