# Rehabilitation of the Thousand Islands Bridges

by Randy Pickle

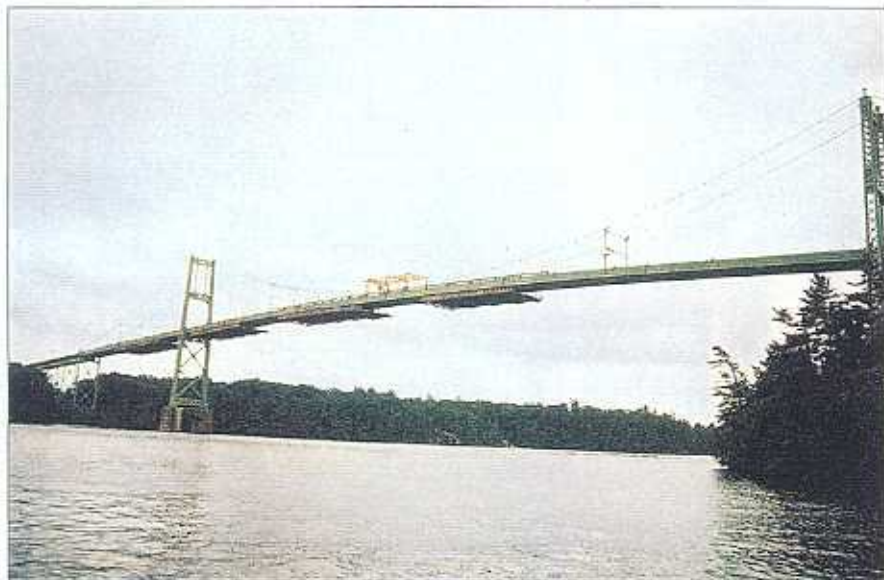
Suspension spans with work platforms and portal frame gantry.

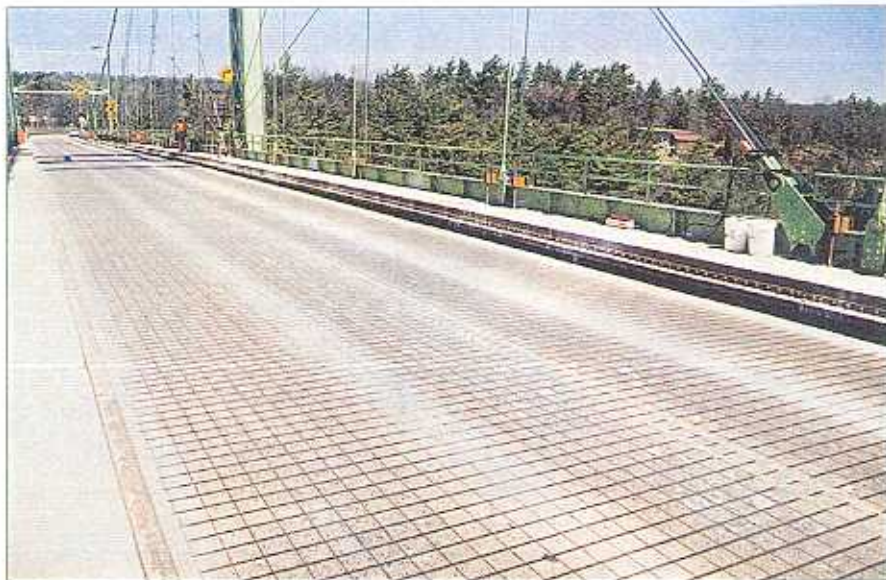
Original deck surface condition on the suspension spans.

The deck systems of the suspension spans and the Warren-truss spans were found to be in poor condition. On the Warren-truss spans, the deck was cracked and separated from the stringers. A number of the floor beams had become warped along the axis of the web. Longitudinal expansion of the concrete deck had occurred as a result of corrosion of the main bars of the steel-grid deck panels. There was also severe spalling of the concrete deck surface as well as cupping of the concrete in the deck panel cells. The deck system of the suspension spans was found to be in a similar condition as that of the Warren-truss spans.

trowel would fall off of the bars or pull concrete out of the cells. This operation appeared to cause unwanted cupping of the concrete in the cells of the panel. This was a condition in the existing deck panels that was to be prevented with the new deck panels. Cupping of the concrete had previously caused increased maintenance requirements on the deck.

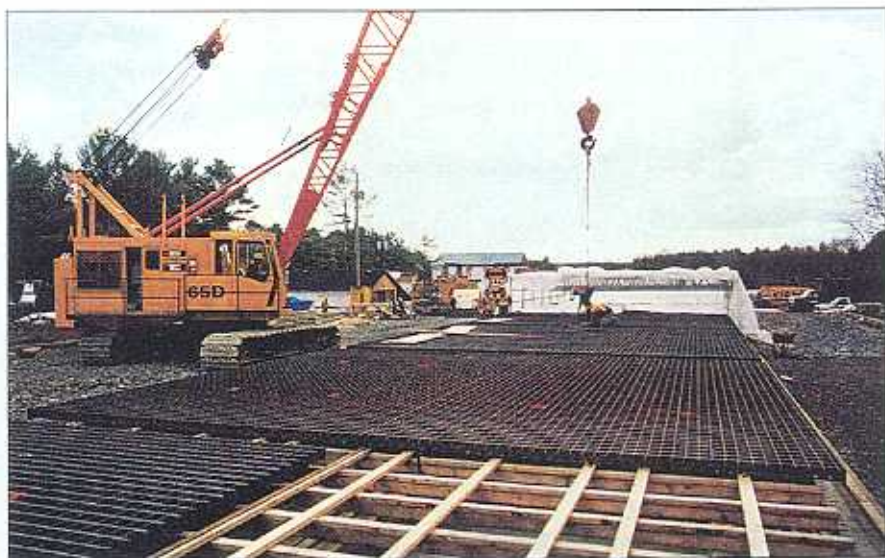
Placing the steel-grid deck panels on the casting table.

With a casting table structure equivalent to the supporting structure of the bridge, the contractor prepared the panels for concrete placement by setting adjacent panels together on the table and temporarily connecting them at their perimeters. The panels were bolted down to the casting table to ensure that the longitudinal grade of the panels, as well as the crossfall from the centerline to the outside edge, was constant. This procedure corrected any minor distortions in the panel bars. The concrete fill shaped the panels to fit the bridge deck supports — floor beams, stringers, and crossbeams — and to mate with the adjacent panels on the structure.

The skeleton panels were placed on the casting table in blocks of six. The length of the casting table permitted the placement of two such blocks on the table. One block of six panels would be prepared and concrete placed. While the concrete in the first set of panels was curing, a second block of panels would then be secured to the table and prepared for concrete placement. After the initial curing of the concrete in

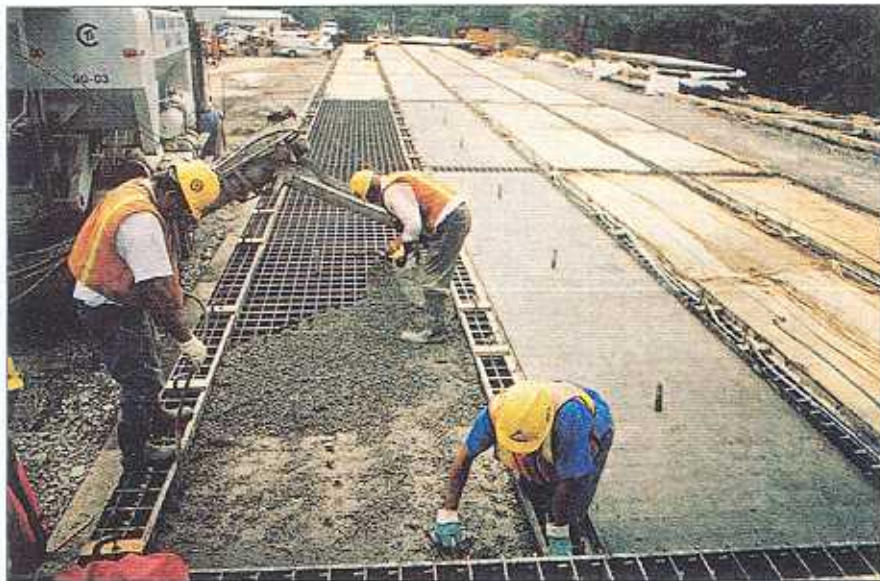
Placing, finishing, and wet-burlap curing of concrete in the deck panels for the Warren-truss spans.

For the initial curing of the panels on the casting table, workers covered the surface with burlap. Then they placed soaker hoses on top of the burlap to keep it in a moist condition for

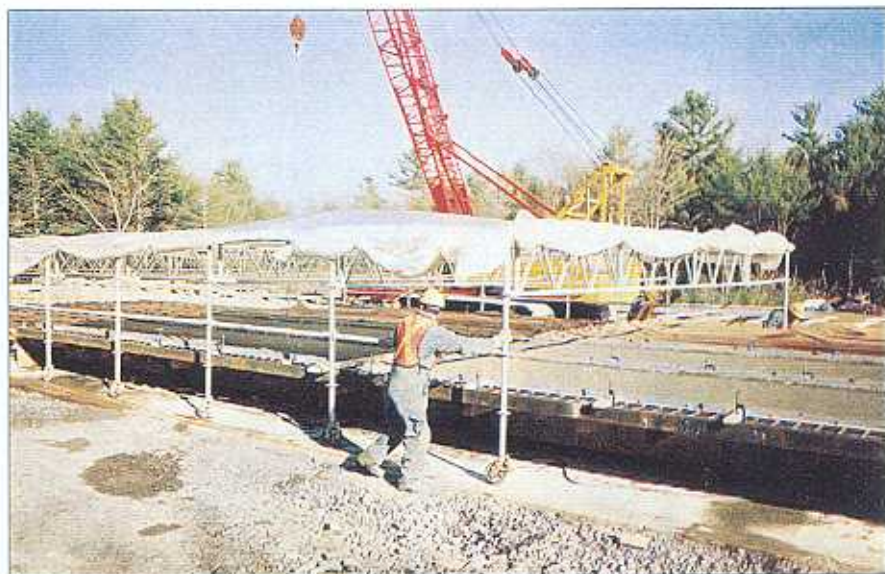
Positioning the polyethylene canopy over the freshly-poured concrete.

For extended curing, workers installed a piping network beneath the casting table. At the east end of the casting table, the piping was connected to a water storage tank. Over the casting table, workers erected an aluminum framework with a heavy polyethylene covering and on wheels to permit mobility.

With cool overnight air temperatures, workers would position the frame over the finished panels and drape the sheeting around the panels to create a full enclosure. Water would then be pumped through the network of piping beneath the casting table and released, as a mist, into the enclosure. This system provided a high-moisture environment for the initial 24-hour curing of the microsilica concrete. The water was not heated to create a steam cure but simply allowed to heat up in the storage tank by solar radiation through the walls of the tank.
